MGP Ingredients Chlorine Release

10/21/2016
Aitchison, KS

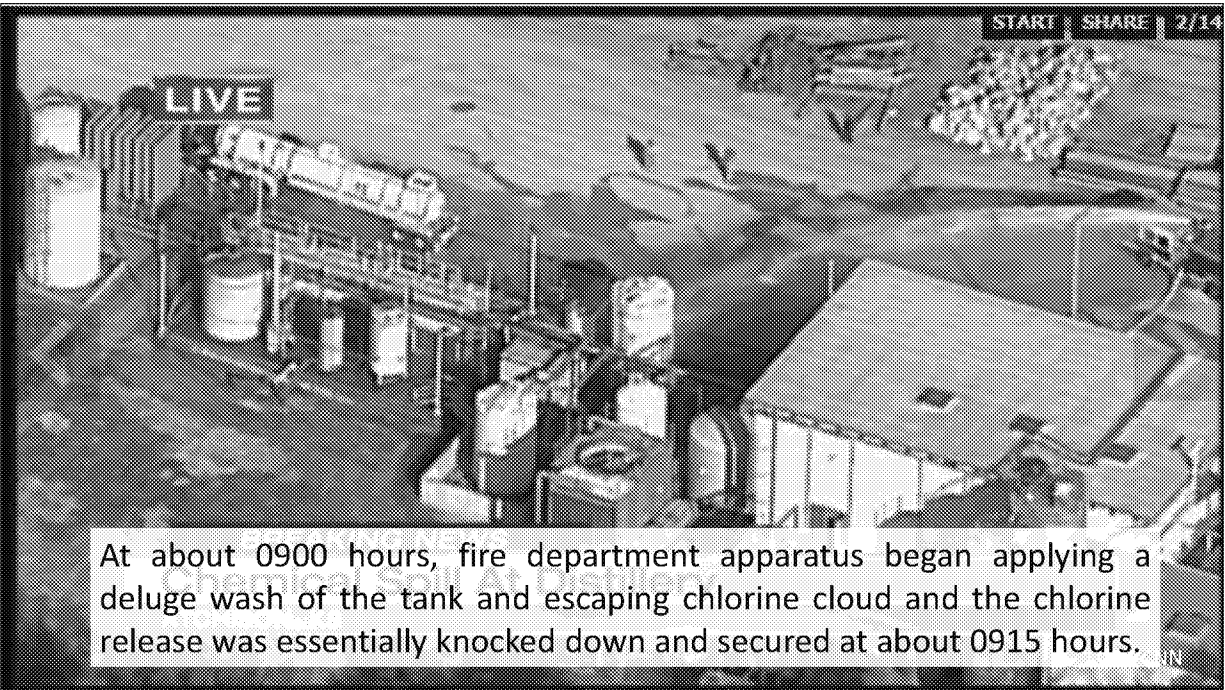
At about 0900 hours, fire department apparatus began applying a deluge wash of the tank and escaping chlorine cloud and the chlorine release was essentially knocked down and secured at about 0915 hours.

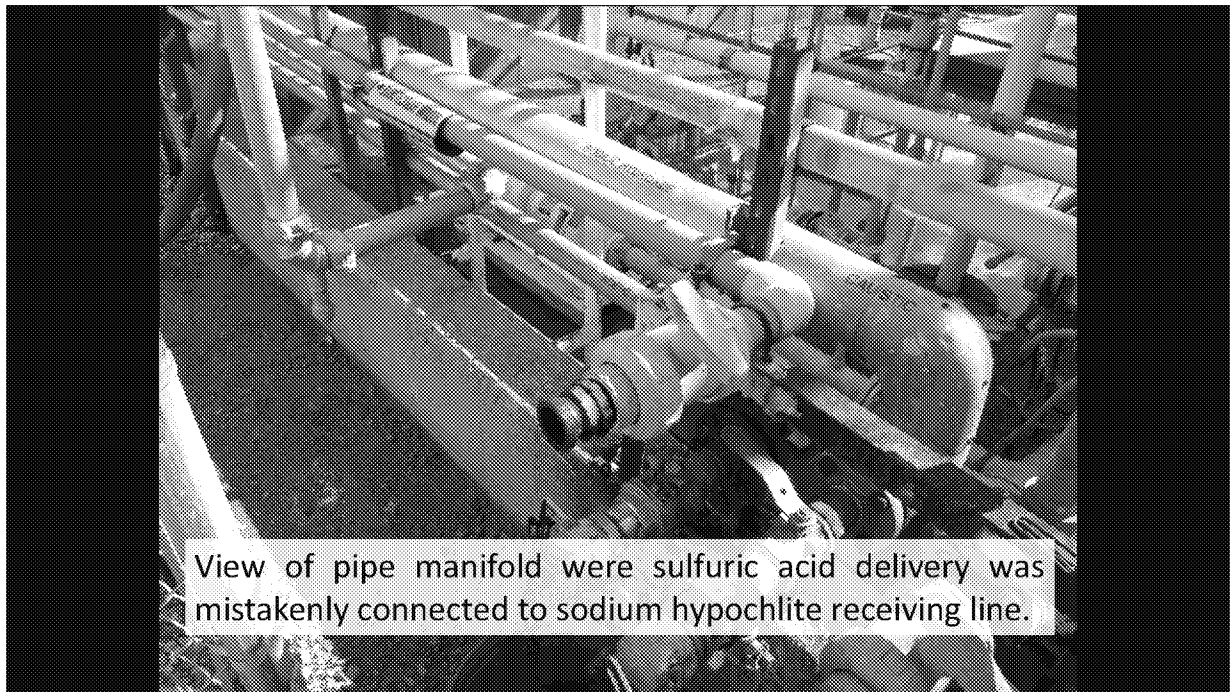
View of pipe manifold where sulfuric acid delivery was mistakenly connected to sodium hypochlorite receiving line.

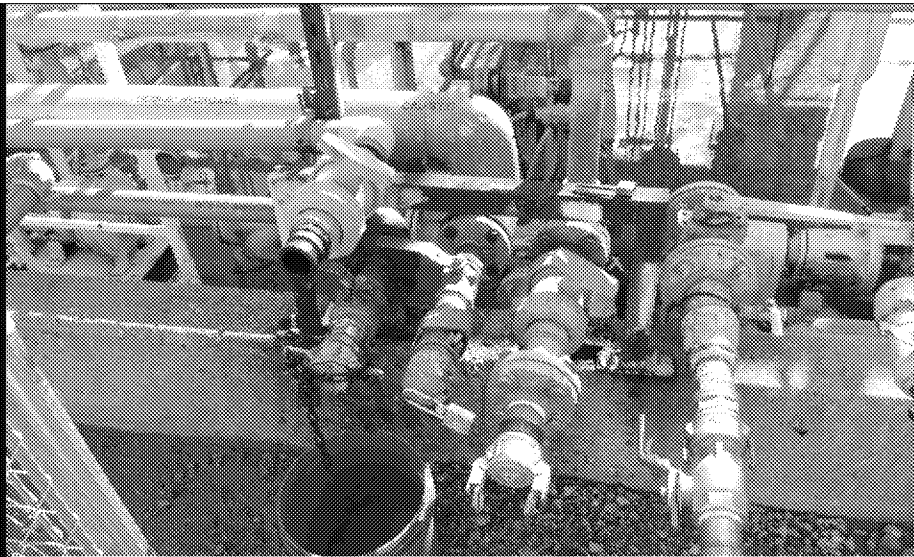
Another view of pipe manifold where sulfuric acid delivery was mistakenly connected to sodium hypochlorite receiving line.

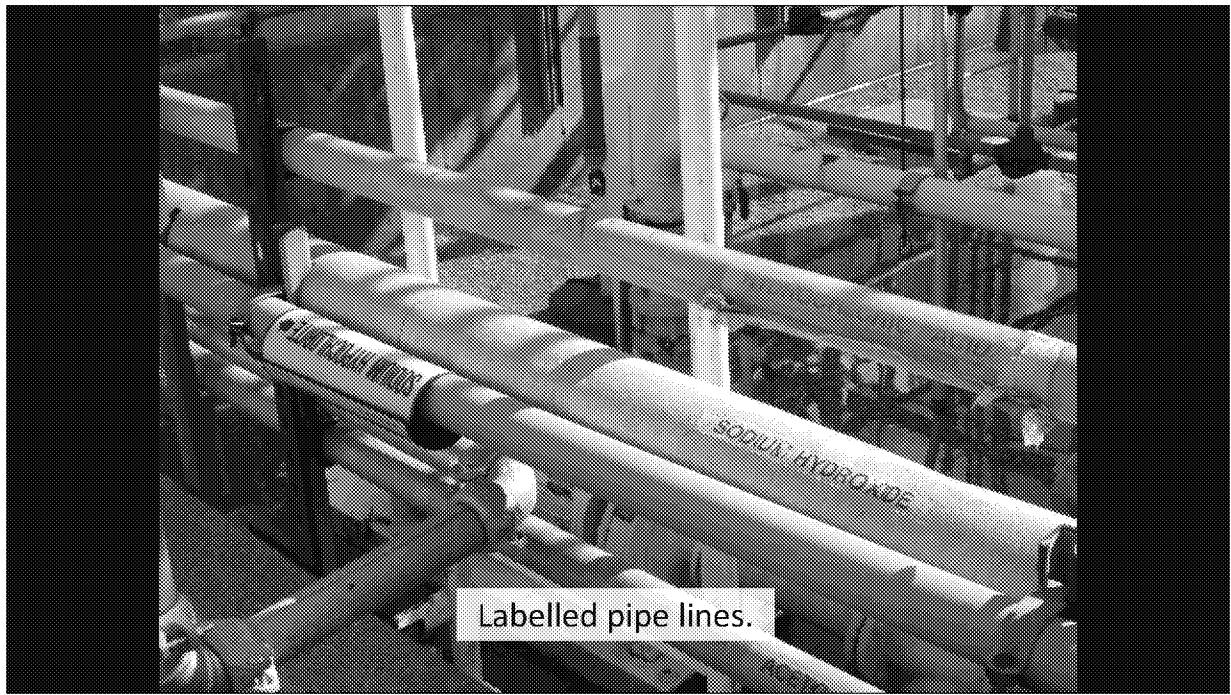
Labelled pipe lines.

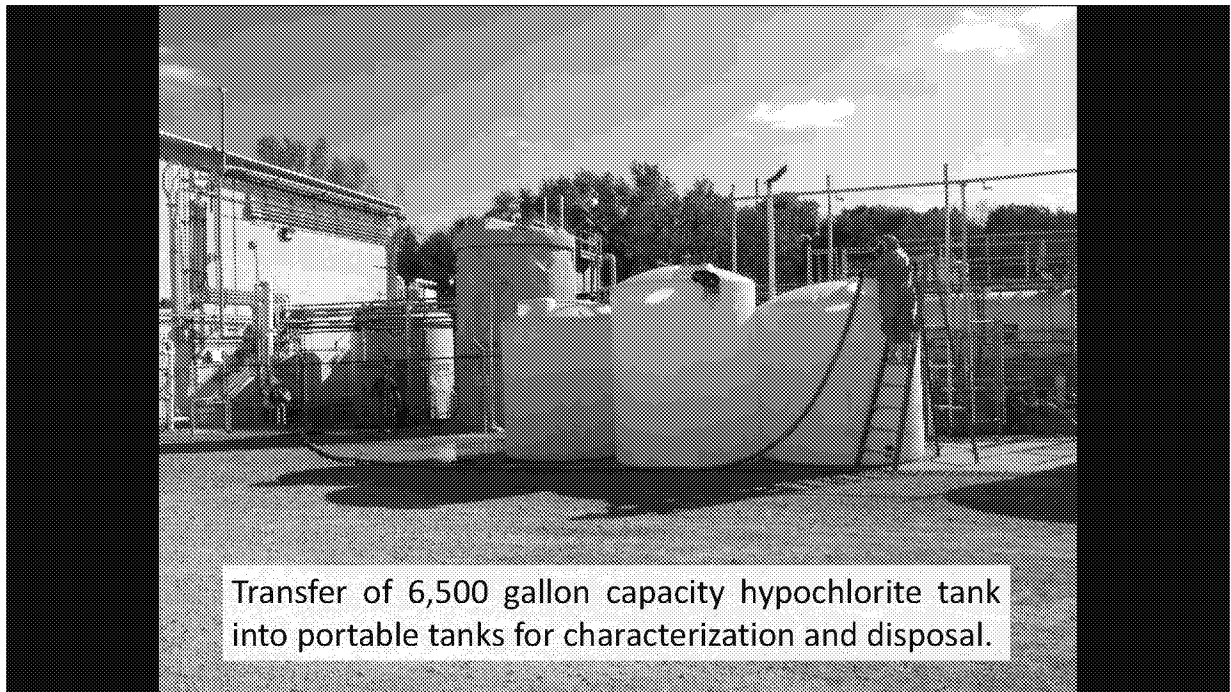
Transfer of 6,500 gallon capacity hypochlorite tank into portable tanks for characterization and disposal.

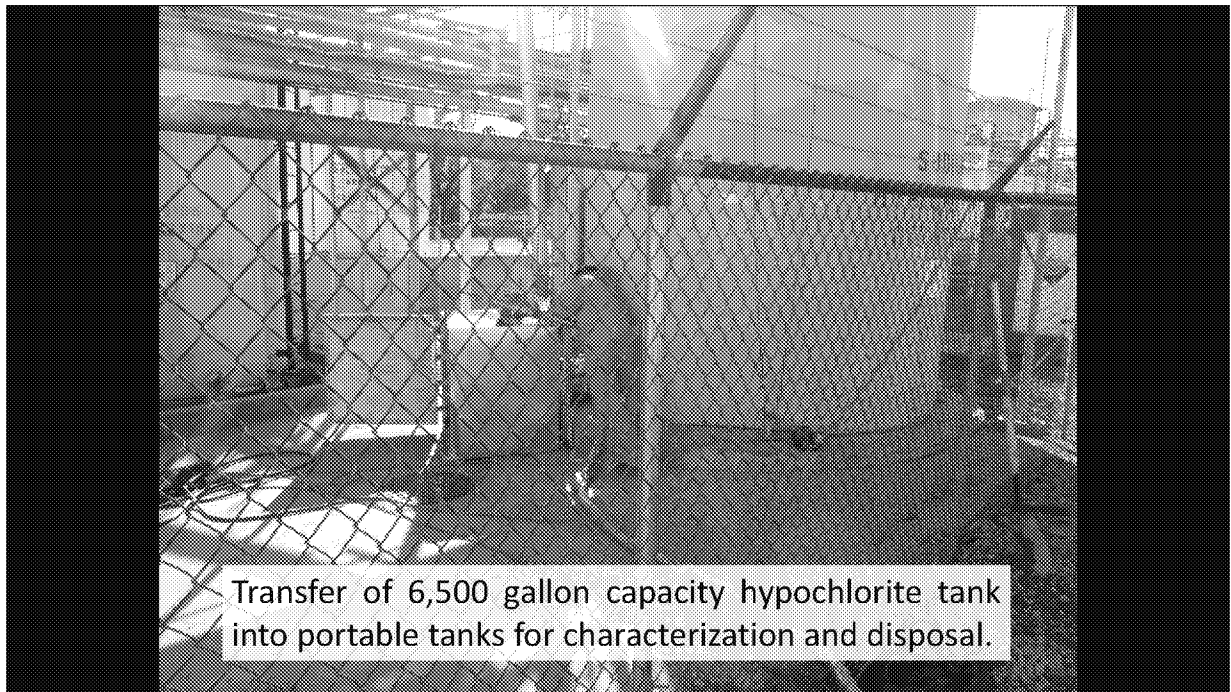
Transfer of 6,500 gallon capacity hypochlorite tank into portable tanks for characterization and disposal.
